Analysing the impacts of widening of Shimla-Kalka national highway and incidence of landslides

Keywords: Highway construction, landslides, Shimla-Kalka National Highway, environmental impacts, resettlement

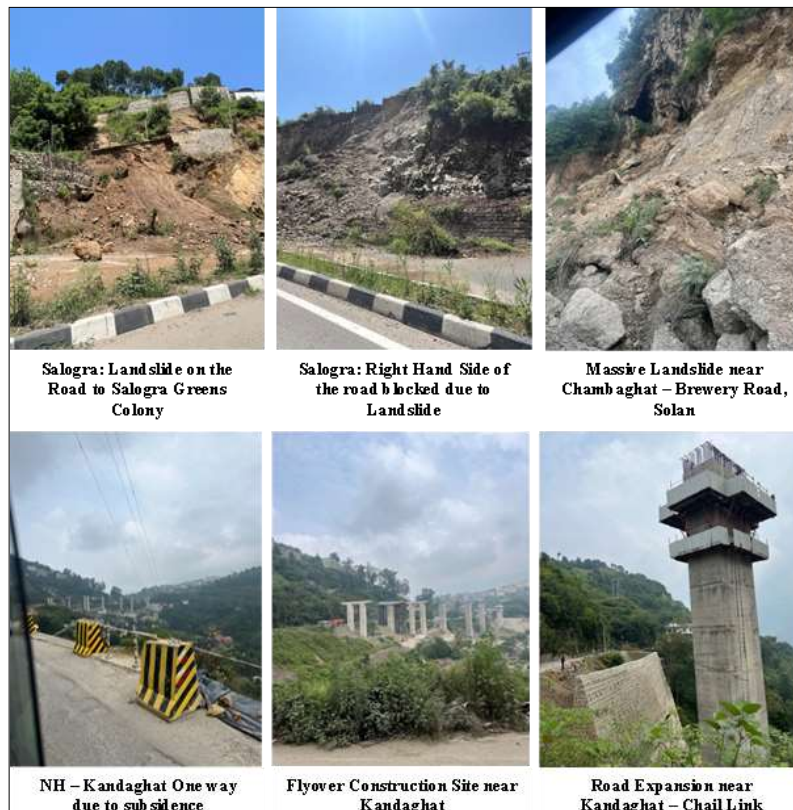
Fig 1

hills and deforestation, continuous landslides and filling up of valleys, pollution of water sources. More than 17000 trees were cut during the construction of NH-05 and pollution levels of towns in between, viz. Dharampur, Solan, Kandaghat, Shoghi, Kaithlight- have increased exponentially. Arevalo *et al.* (2020) [1] described the impact of highway construction. Researchers observed that such projects besides many benefits, affect the local environment. When the construction works were carried out many residents had to migrate from their native place. Similar observations were made during the present study. Kahlon *et al.* (2014) [4] described the occurrence of landslides in the Himachal Pradesh as a major threat mainly in the monsoon season which has increased due to anthropogenic activity such as road construction, expansion of settlements and other allied developmental activities, deforestation and changes in agriculture pattern. As of the present study when the construction phase was carried out, stripping and cutting of the land was done to widen the road, thus increasing the incidences of landslides and erosion activity which is more significant in the monsoon season. Rock fall, debris flow and blockage of the road create traffic problems. Walls constructed along the roadside are affected by the landslides and has resulted debris flow on the road or roadside. Thousands of trees were cut down including the commercially and ecologically important trees to expand the highway affecting the local environment Similarly, Kumar *et al.* (2011) [5] described the Indian highways in the mountainous terrain suffer from more landslides event due to rainfall and the sliding event became more recurrent resulting in repeated restoration which further result in direct and indirect losses. Therefore planned construction is suggested including the hazard and risk management plan, construction and maintenance of the road for risk-free road development.
